## VRCC Repair and Refurbishment Solution

The Vestas Rotor Current Controller (mainly used on V47 Turbines) consists of a Resistor, Processor and Power Unit. These units can be serviced individually or as a set.

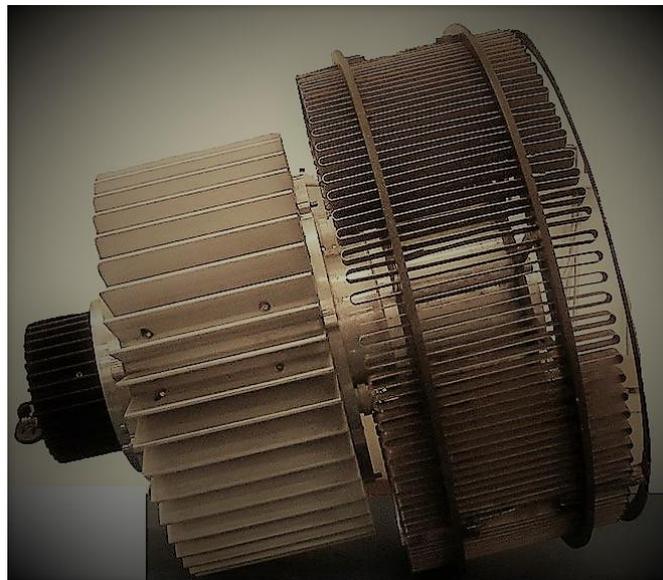
705180	VRCC Power Module
CT273	VRCC Control Unit
705100	VRCC Resistor Unit

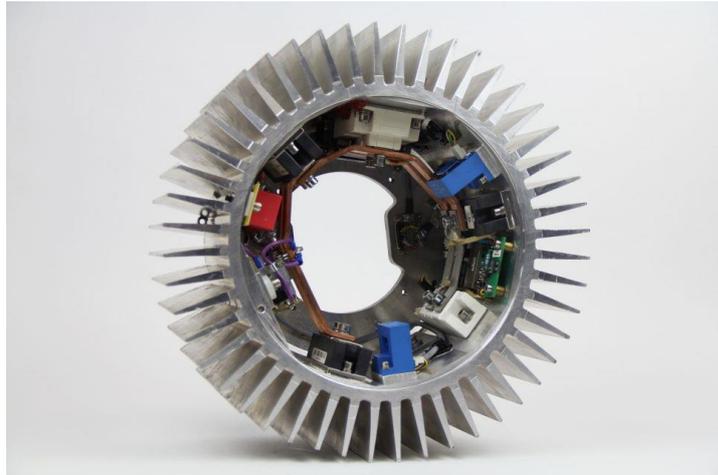
## VRCC Power Module

Before any work is carried out on the power electronic unit a visual inspection will be carried out on all electronic components looking for:

- a. Discoloring caused by over temperature, Smoke, Flash-over
- b. De-soldered or loose components, Solder splatter around components

Dismounting and thorough cleaning of all components will be carried out and sandblasting of the outer body of heat sink. **Note: After sandblasting serial number may need to be restamped.**

Due to the high failure rate the Akuray Repair Solution replaces all components with newly manufactured modules and devices. The driver board is replaced with a board assembly specifically designed to improve reliability of the unit. The Over Voltage Protection (OVP) board is stress tested and replaced if one of the components is defective.

- a. Snubber circuit
- b. Diodes
- c. Current Transformers
- d. IGBT
- e. IGBT Driver
- f. Thyristors
- g. Thyristor Driver
- h. PT100 sensor
- i. OVP circuit

Before final testing is done, all bolt connections will be checked and sealed for proper bolt torque. The unit will also to be balanced.

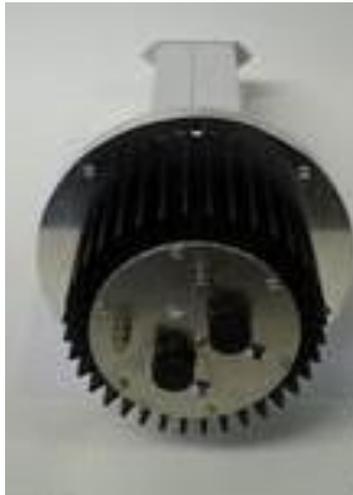
## **VRCC CT 273 CONTROL UNIT:**

Before any work is carried out on the control unit a visual inspection will be carried out on all electronic components looking for evidence of overheating, melted plastic, arcing and damaged components, anything visible that may have caused the malfunction of unit.

The control unit will be checked for a noisy or dragging bearing, broken and damaged cable connections (supply and communication), any loose or broken electrical connection and alignment of optical connections.

- Bearings - 100%
- Capacitors - 100%
- LEDs, Optislip components, controller boards, etc. – as required

- a. Feed Card
- b. Communication Card
- c. LED Diodes
- d. Analog Inputs
- e. Current sensors
- f. RAM
- g. Flash Memory
- h. IGBT Error

Once all electrical and mechanical components have been replaced the unit is placed through a final test using the AKURAY custom made software ([see below](#)) and test equipment.

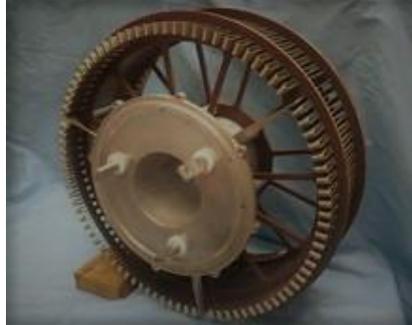
## **VRCC RESISTOR UNIT:**

Before any work is carried out on the resistor unit a visual inspection will be carried out looking for evidence of overheating, a break in the resistor or a broken weld.

Repairs are carried out using the same alloy material used in the original component, welds are checked and rewelded if necessary in all connection points. Bolts and isolators are checked and replaced if necessary. A new O-ring will be supplied.
